The Northern Chaco Outliers Project Annual Report, 2018 Field Season

*Samantha G. Fladd, Rebecca L. Simon, Susan C. Ryan, Shanna R. Diederichs,
Kari L. Schleher, Caitlin A. Sommer, Steven R. Copeland, and Grant D. Coffey*

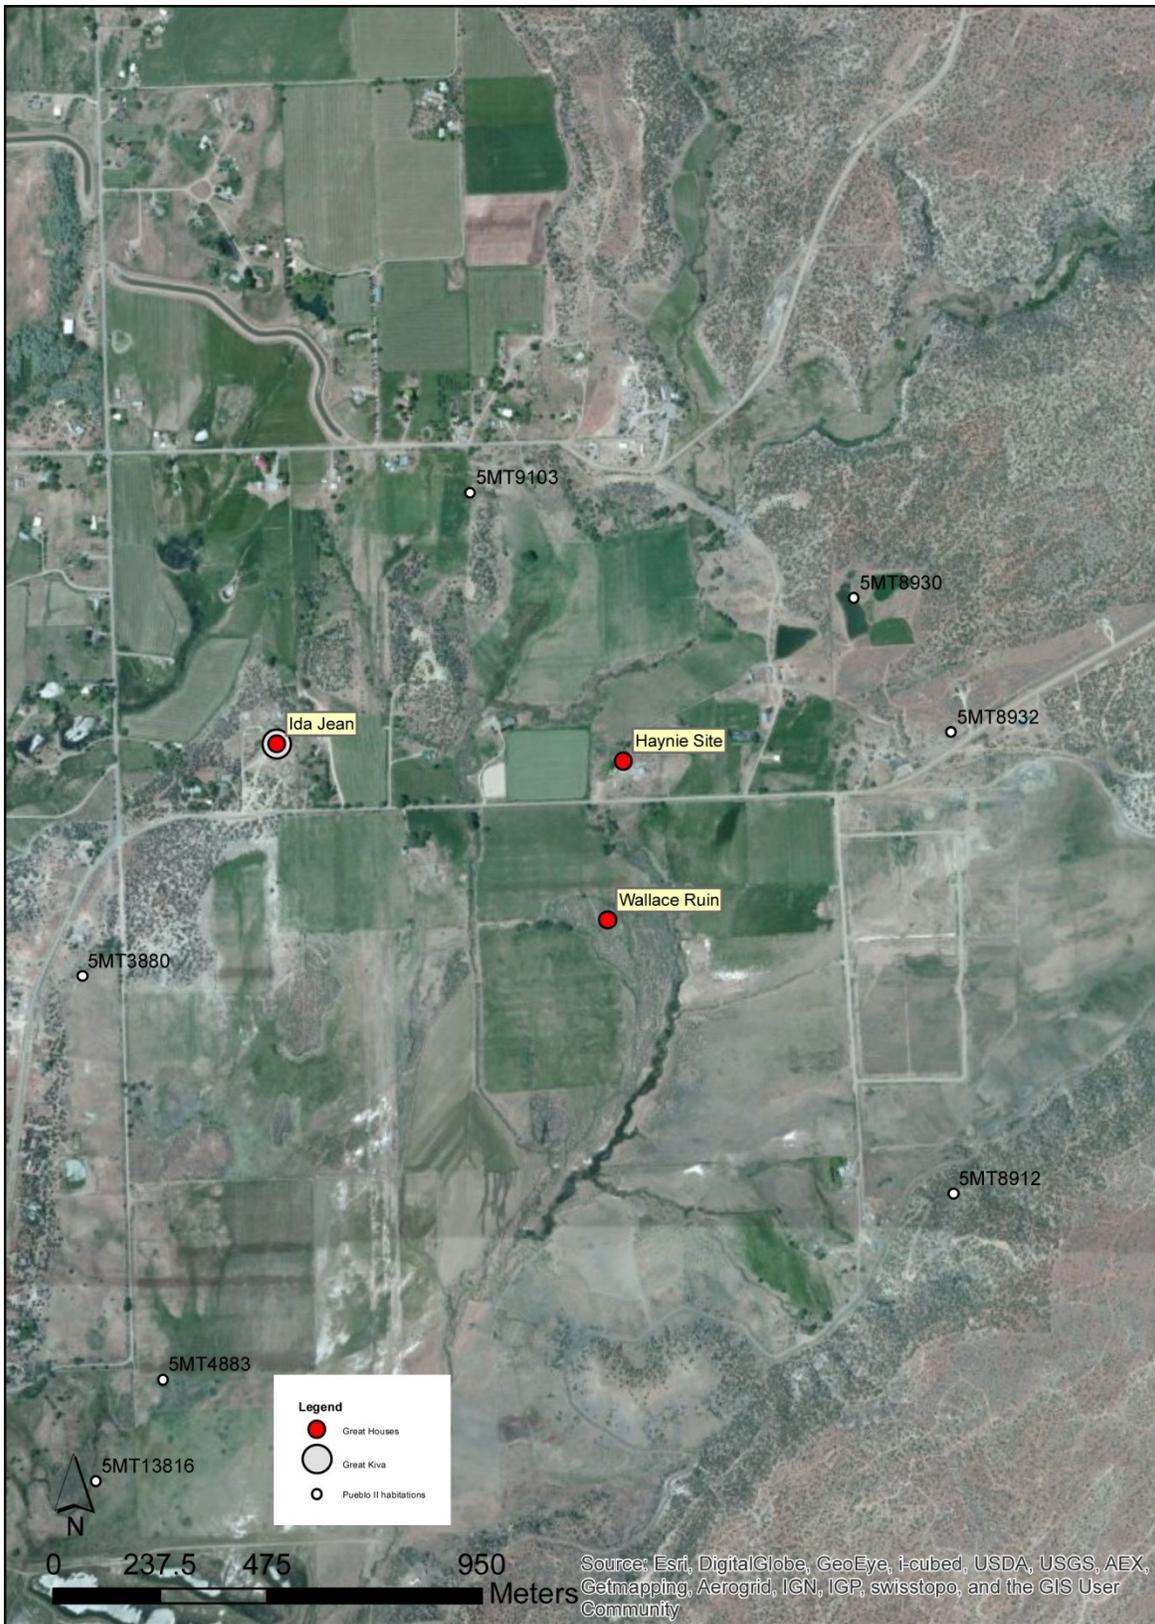
Figure 3. Locations of sites in the Lakeview group and of surrounding sites.

The NCOP study area includes an environment defined by the surrounding drainages and by current agricultural use of the land. Figure 3, an aerial image captured in the 1990s, shows the locations of sites in the Lakeview group as well as of other sites nearby. The Haynie site is located at 6270 ft (1911 m) and is situated on a small knoll to the north of, and just above, a shallow broad valley within Simon Draw. The head of Simon Draw is located about 6 km north of the Haynie site. Simon Draw empties into McElmo Creek 4 km southwest of the Haynie site.

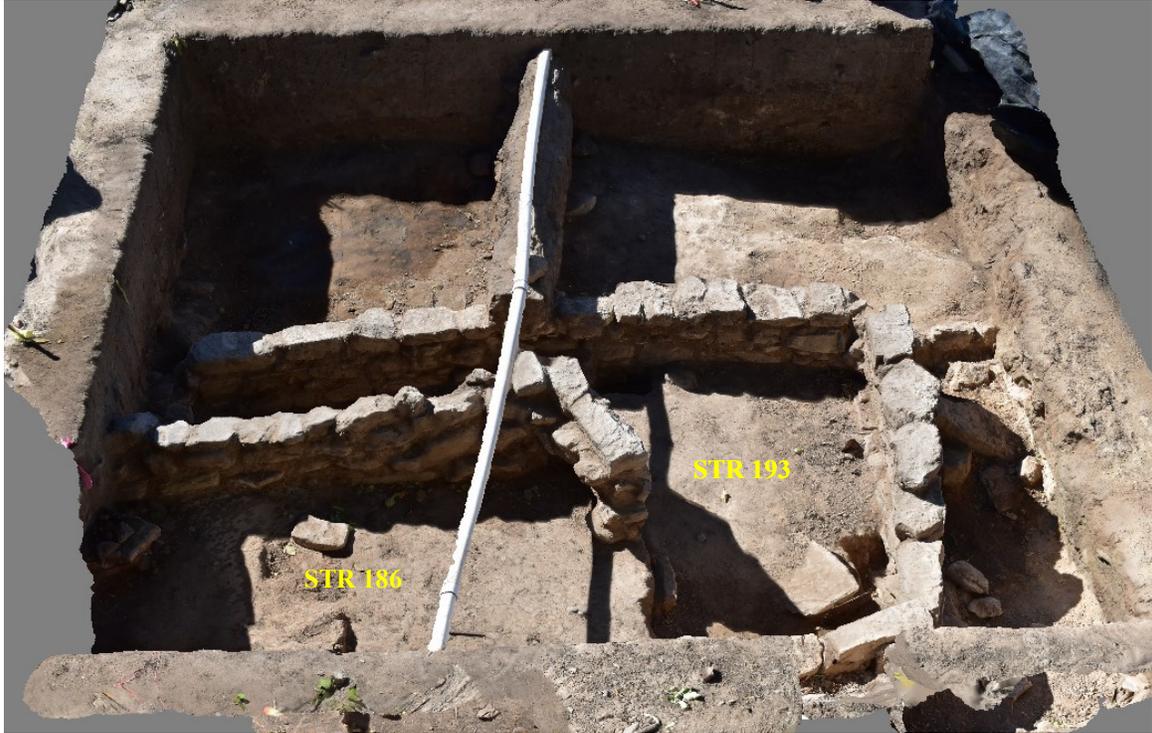
Figure 5. Oblique view of Structures 186 and 193 from photogrammetry model (view west), the Haynie site.

Located west of the modern house, Structure 186 (Figure 5) is a room featuring single-coursed masonry that was built within an earlier structure, Structure 193 (Simon et al. 2017). These structures were identified in 2017, and excavations continued during the 2018 season within two 1-x-1-m units and a 2-x-2-m unit. Additional portions of the floor of Structure 186 were exposed in 2018. Excavations will continue in 2019.

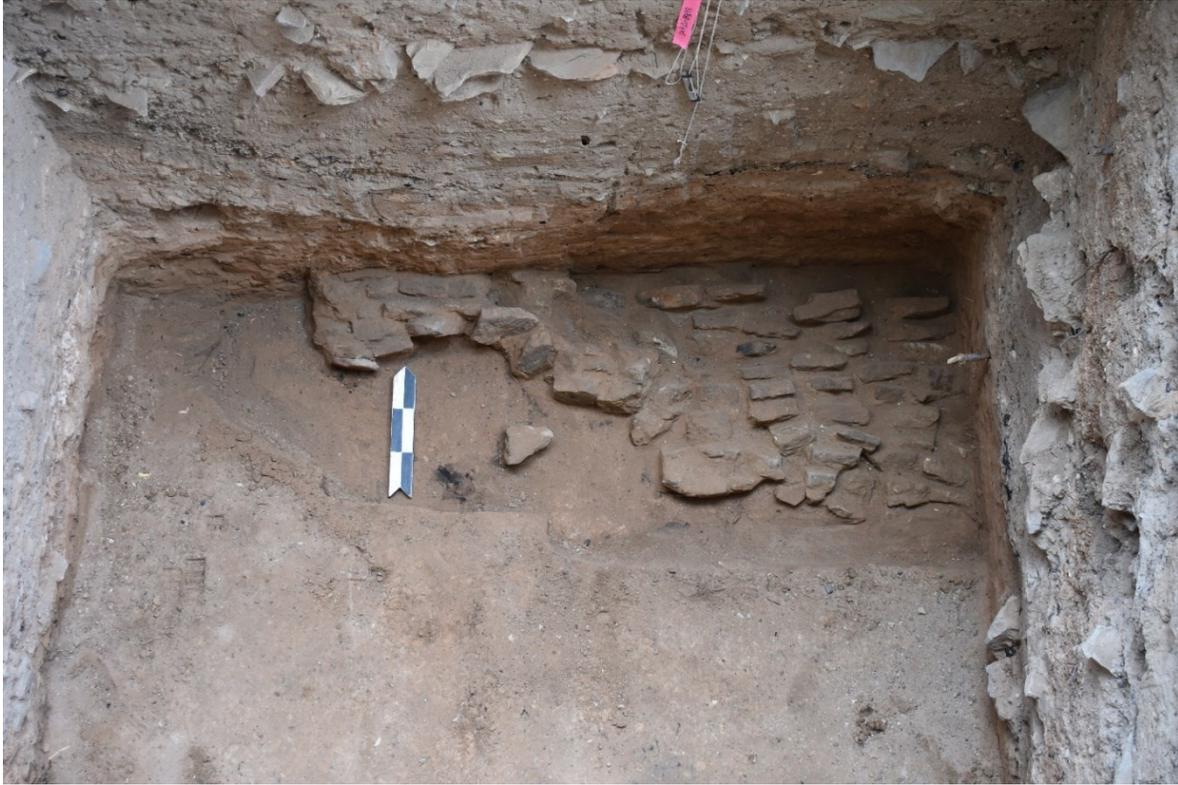
Figure 6. Exposed fallen masonry in Arbitrary Unit 1012 (view north), the Haynie site.

A 2-x-2-m unit was placed south of the standing walls of the west great house. In 2017, numerous deposits were excavated in this unit, including an extramural surface and a pit feature (Simon et al. 2017). In 2018, Nonstructure 190, a midden containing sherds, flaked-lithic debitage, ground-stone artifacts, calcite minerals, nonhuman bone, projectile points, and burned maize cobs, was excavated. This midden is more than one meter thick. Beneath the midden, in the northeast corner of the excavation unit, fallen masonry, probably from a pit structure, was documented at the end of the 2018 season (Figure 6). Excavations will continue in this unit in 2019.

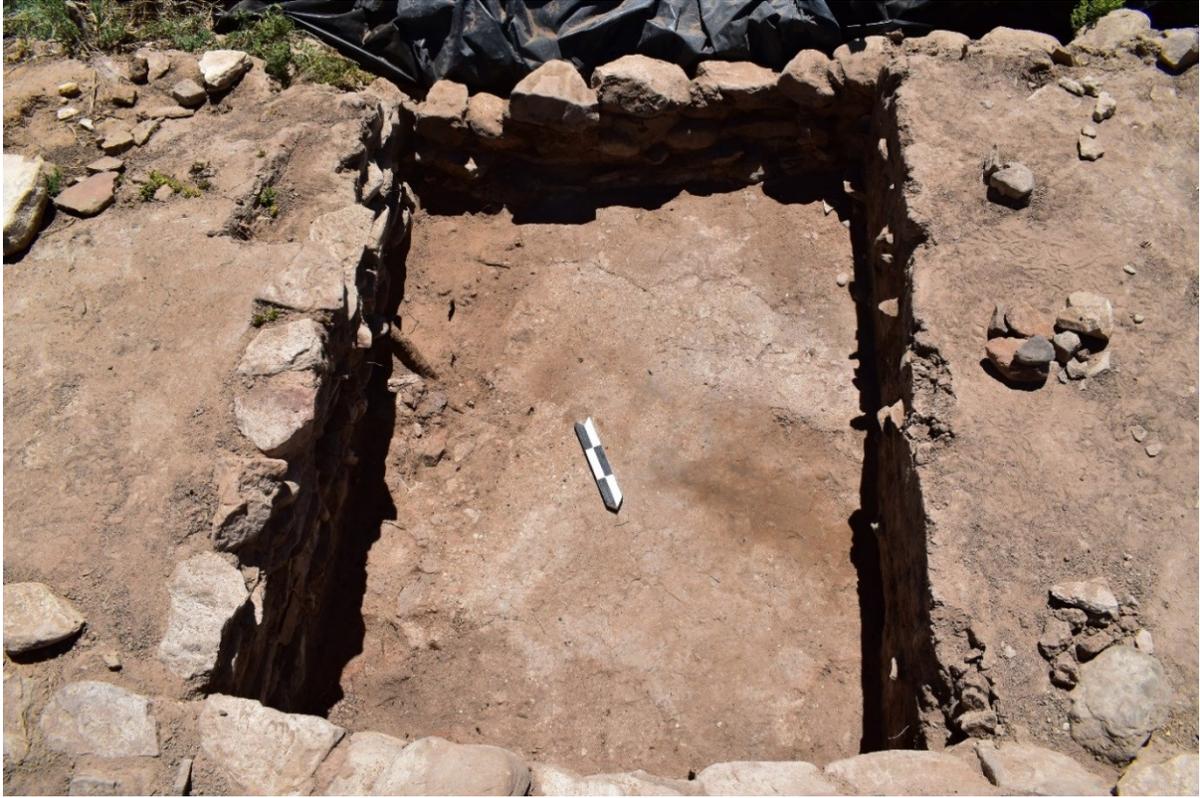
Figure 7. Surface 1 in Structure 197 (view southwest), the Haynie site.

In the northwestern portion of the site, due west of the remains of the west great house, masonry walls of irregularly shaped and globular sandstone rocks that had been exposed by nonprofessional digging led to the definition of the north, east, and west walls of Structure 197 in 2017 (Simon et al. 2017). Excavation in 2018 defined the south wall of this room. Wall fall and then roof fall deposits were removed from the structure. Just below the roof fall stratum, a use surface was encountered (Figure 7). More than 50 artifacts were mapped and collected from this surface. Underlying this surface was construction material, which indicated that the structure contained an earlier surface. The original floor consists of undisturbed native sediment on which the walls had been built. Rodent activity had destroyed much of this floor, and no artifacts were found resting on this surface. Work in Structure 197 was completed in 2018, and the room was backfilled.

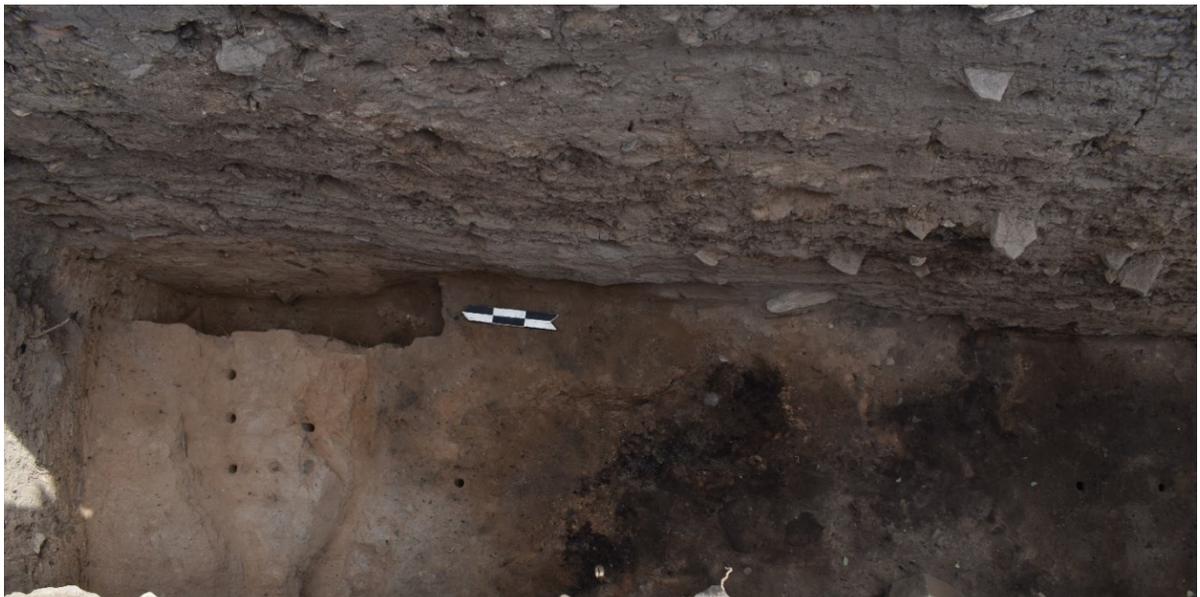
Figure 8. Excavation in progress in Structure 1002, showing burned roofing (view east), the Haynie site.

Structure 1002 is a pit structure located in the east trench beneath Nonstructure 192 (see Nonstructure 192 section, above). The south wall of the structure is formed of decomposing bedrock and is located about 40 cm north of the south edge of our trench. The north wall of this structure has not yet been defined, but the length of the pit structure must be greater than the 5.6 m excavated in the units north of the south wall. Excavations in 2018 focused on roof-collapse debris, particularly a heavily burned section in the north excavation unit (Figure 8). Numerous artifacts, including multiple projectile points, were found within this burned debris. The floor of this pit structure will be exposed in 2019.

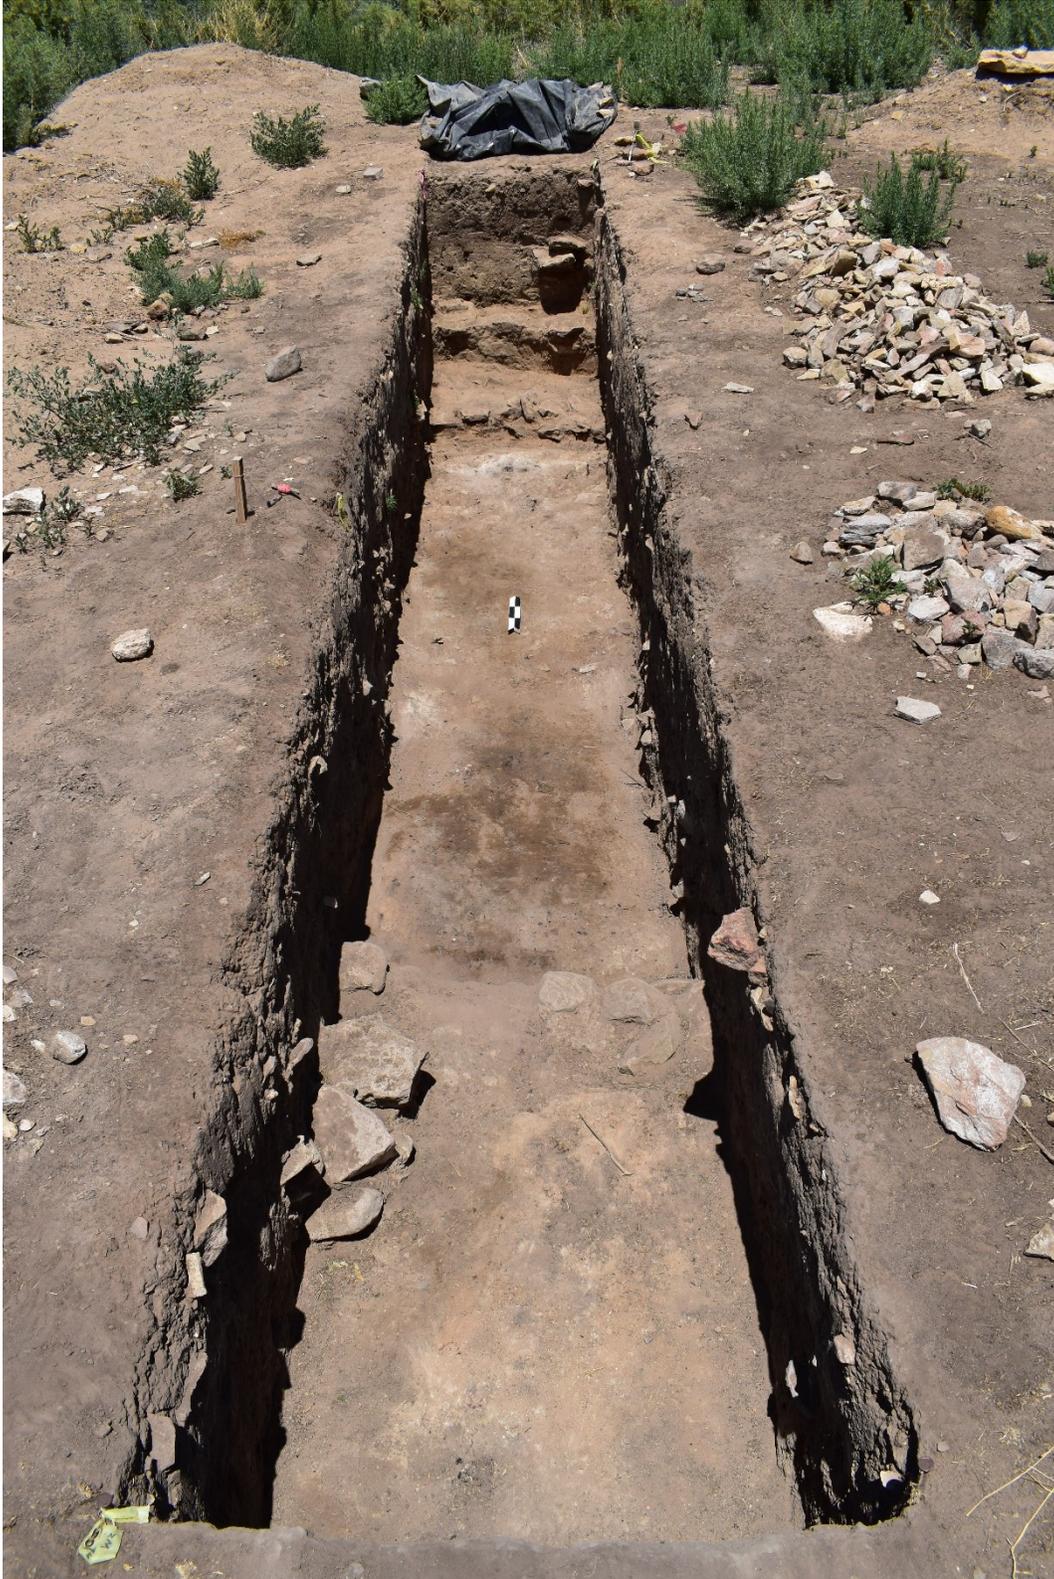
Figure 9. Excavation in progress in Structure 1003, showing roof fall and tops of walls (view north), the Haynie site.

Structure 1003 is a pit structure exposed in the west trench beneath Nonstructure 192 (see Nonstructure 192 section, above). Masonry walls consisting of single-coursed shaped sandstone rocks and mortar were encountered in both the north and south ends of the trench, indicating a north-south dimension of 4.0–4.5 m for the exposed section of the structure. A bench about 40 cm wide that was composed of similar masonry was defined in the north end of the structure. A possible vent identified in the south wall will be explored in 2019. Excavations in 2018 focused on removing thick roof-fall deposits from the interior of the structure (Figure 9). Several bone awls and large pottery sherds were found within this material. Additionally, a stone tablet and a tablet made of pottery clay were collected. Excavations in 2019 will expose the floor of this pit structure.

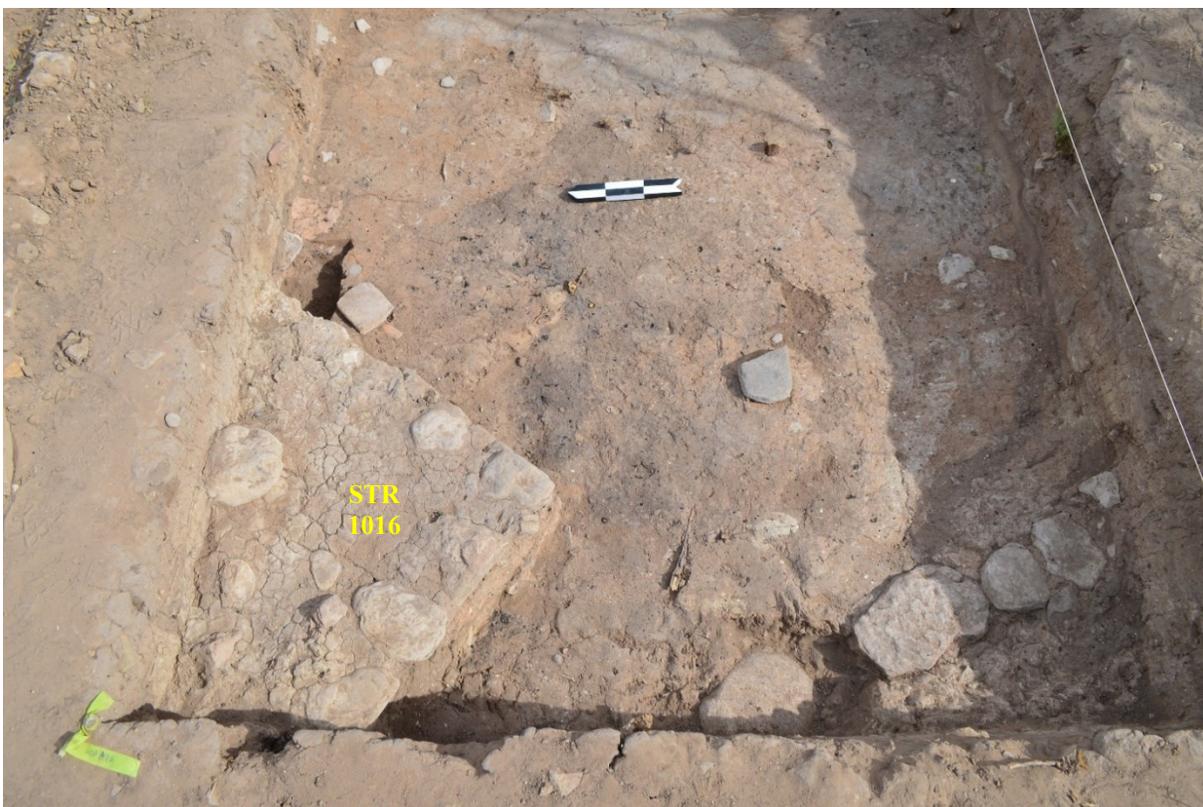
Figure 10. Oblique view of Nonstructure 1015 showing in situ artifacts and Structure 1016 (view east), the Haynie Site.

Nonstructure 1015 is an extramural surface defined in portions of the west 2-x-4-m unit located adjacent to the northwest corner of the west great house (Figure 10). This surface is ephemeral and does not appear to be prepared. Two mano fragments, two pottery sherds, and a fragment of animal bone were associated with this surface. A corner of Structure 1016 rests on this surface in the northwest corner of the exposed area. A diagonal alignment of rocks in the southwest corner of the unit may be associated with this surface.

A corner of Structure 1016 was built on the Nonstructure 1015 extramural surface and is located in the northwest corner of the 2-x-4-m unit (Figure 10). The masonry is single-coursed and composed of a mix of shaped and unshaped sandstone rocks and mortar. Excavations will be expanded to explore this structure in 2019.

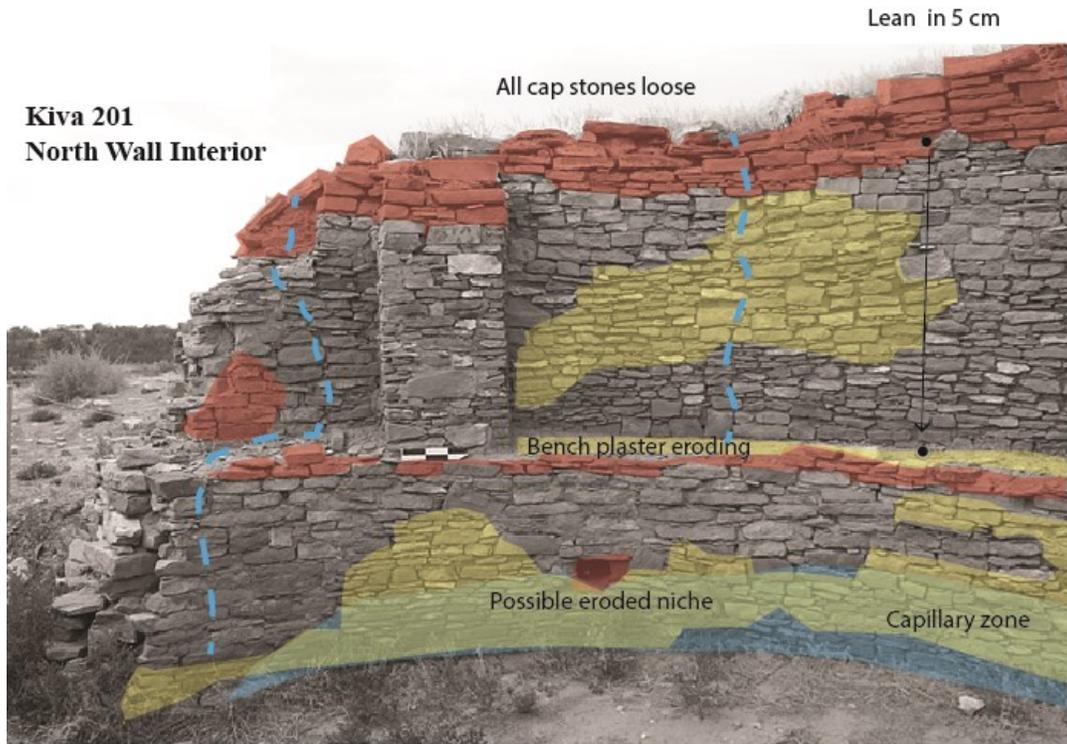
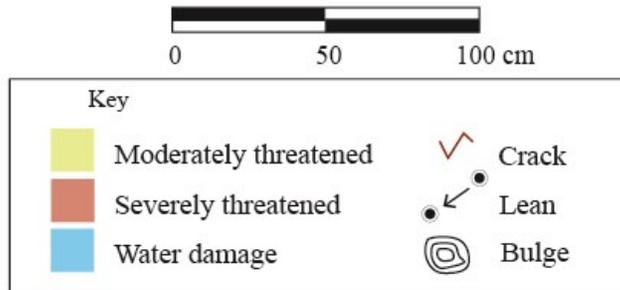
Figure 14. Condition assessment annotation for the north interior wall of Kiva 201 in the east great house.

Each structure wall was assessed individually (Figure 14). Condition assessments were then used to determine the appropriate stabilization activities for each of the structures, including the establishment of a safe path to be used by staff and visitors to the site when walking on the east

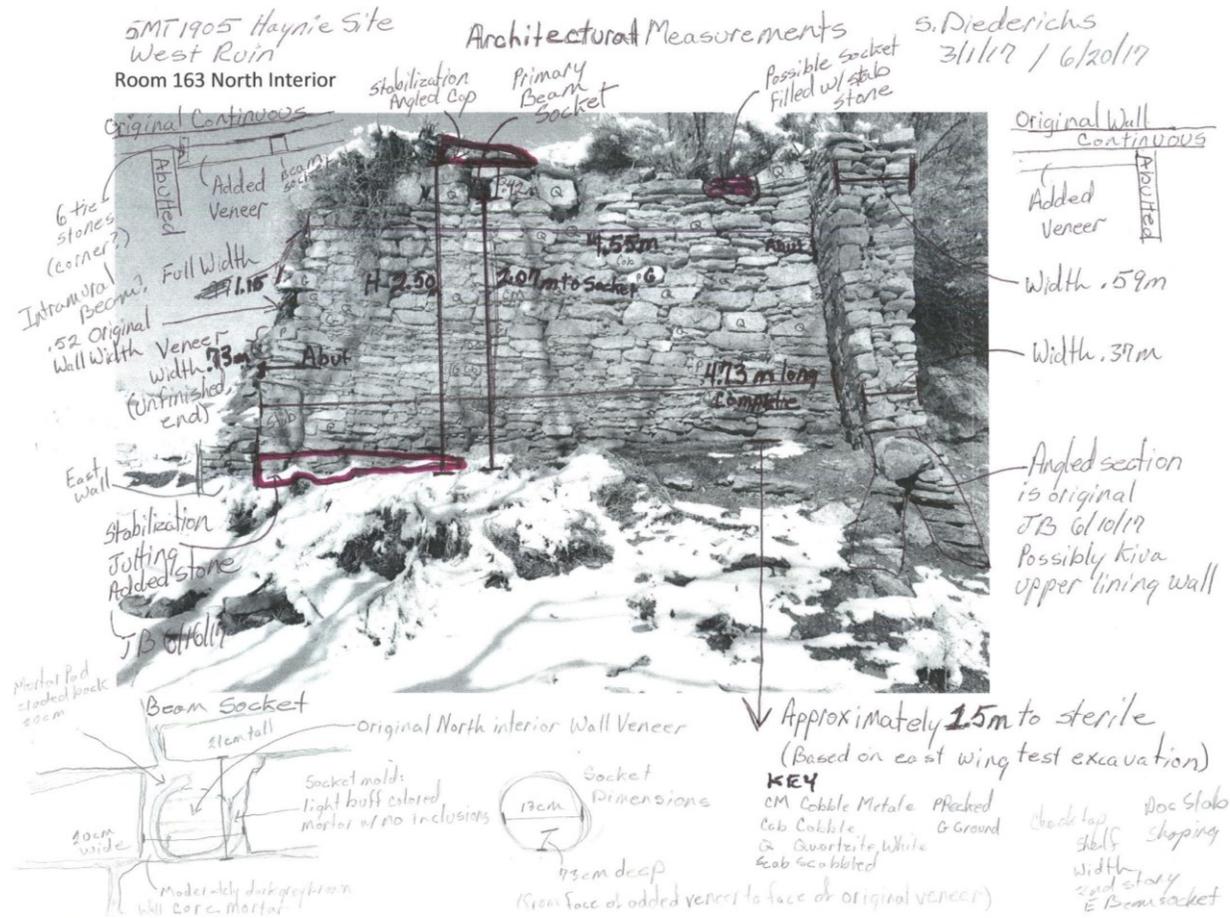
Figure 15. Architectural documentation annotations for the interior face of the north wall of Room 163 of the west great house, the Haynie site.

Basic measurements and construction details are recorded during the architectural documentation phase. All information is recorded on Crow Canyon masonry forms and annotated on printed wall-elevation photographs (Figure 15). Commonly recorded attributes include measurements, types of construction and wall abutments, construction materials, number of exposed courses, and chinking styles. Measurements include height, length, and width of the wall and the number of courses visible. Wall-abutment patterns are recorded to determine the relative construction sequence of walls within a room and the construction sequence of a room in relation to adjacent structures. Architectural features (entryways, vents, beam sockets, ledges, etc.) are recorded with sketches and detailed descriptions.

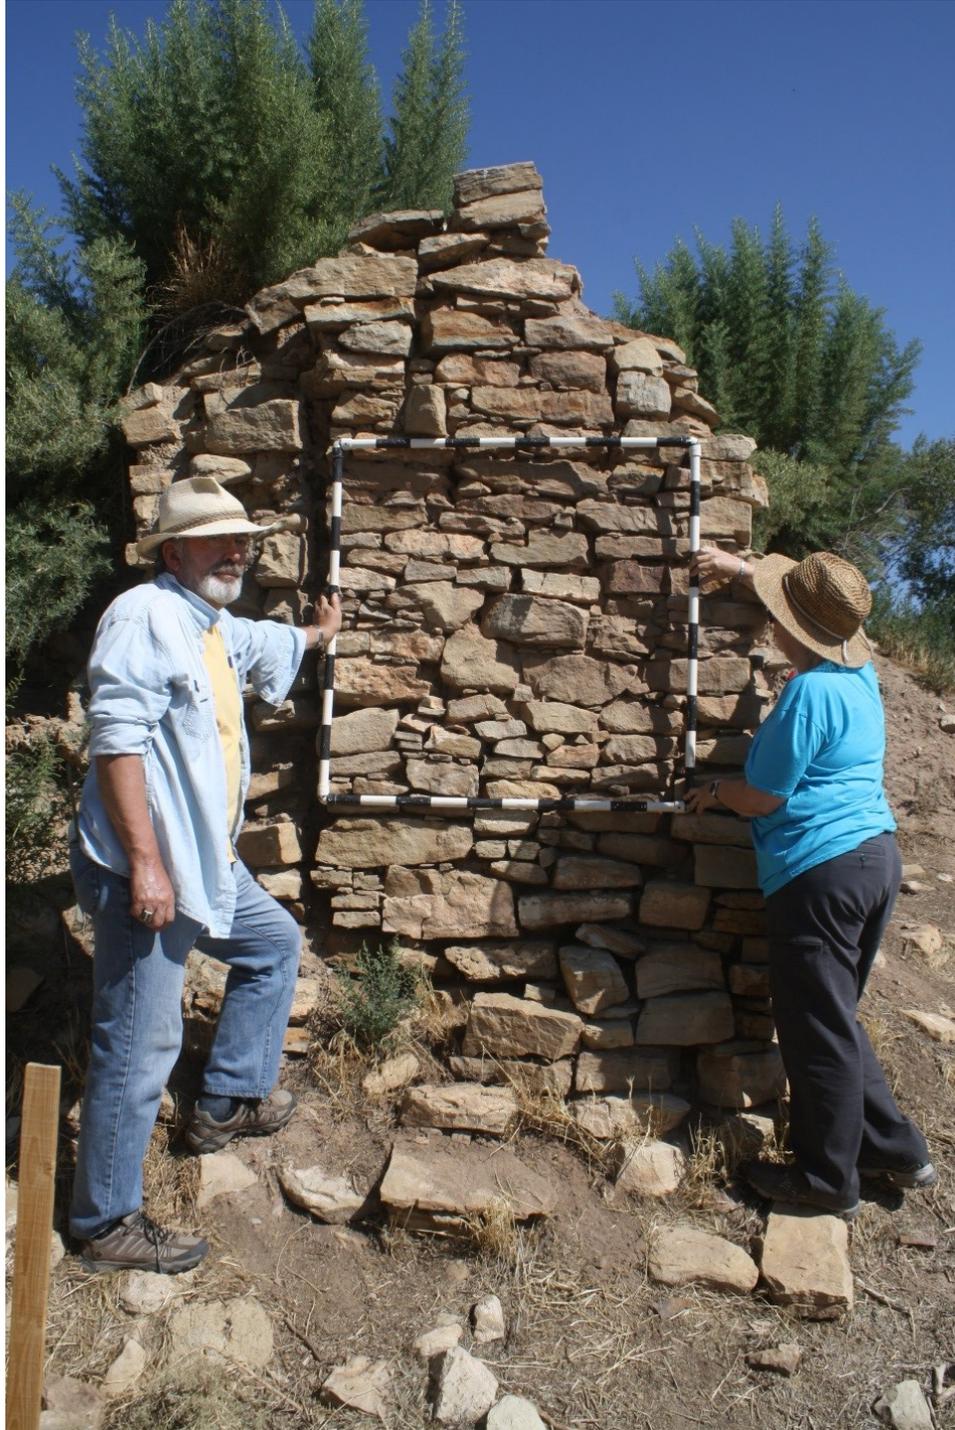
Figure 16. Veneer sampling of the remains of the west great house by Earthwatch Institute volunteers, the Haynie site.

To compare masonry-veneer styles observed at the Haynie site to veneer styles that have been documented at other ancestral Pueblo sites, Crow Canyon is collecting detailed measurements from each wall face. This is being done in accordance with the Intermountain Region National Park Service Architectural Documentation Sheet 3-Veneer Transects form (Nordby et al. 2008). Veneer sampling entails measuring the length of stones and of mortar gaps along each masonry course in a 1-x-1-m section of veneer (Figure 16). Crow Canyon will compare these data to

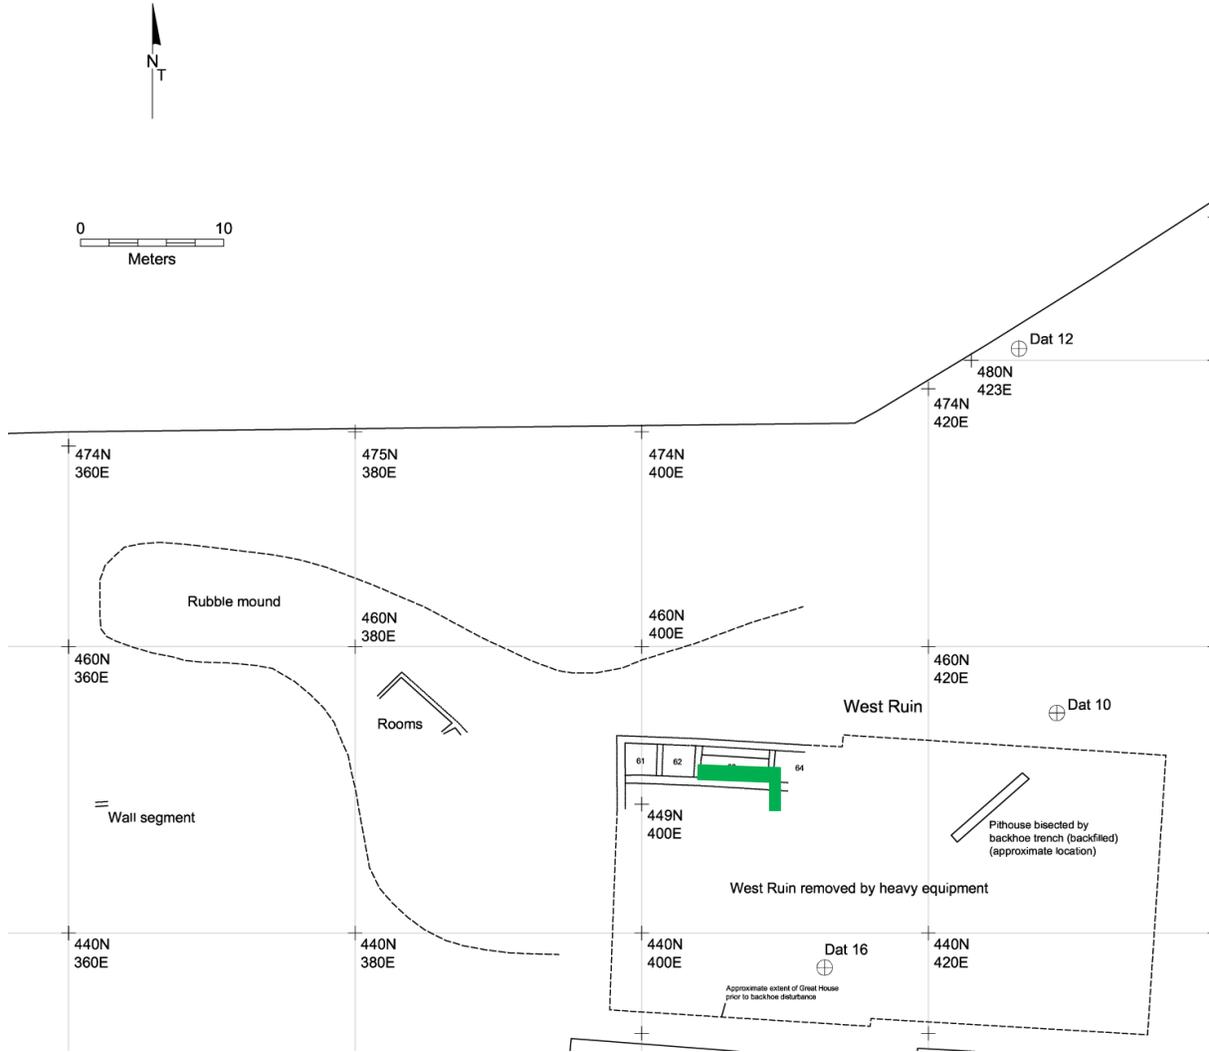
Figure 17. West great house, the Haynie site; masonry walls stabilized during the 2017 field season are highlighted in green.

In 2017, a few walls were minimally stabilized (Simon et al. 2017) to mitigate immediate safety threats. All standing walls in the west great house were documented, and two walls in Room 163 were stabilized (Figure 17). In the east great house, architectural documentation began in three of the 14 exposed rooms. In addition, a short demonstration wall was constructed for educational purposes north of an auto-body shop near the modern house. Crow Canyon archaeologists Shanna Diederichs and Kate Hughes supervised Crow Canyon adult participants in all documentation and stabilization activities. For a more detailed discussion of this work, see Diederichs 2018 and Simon et al. 2017.

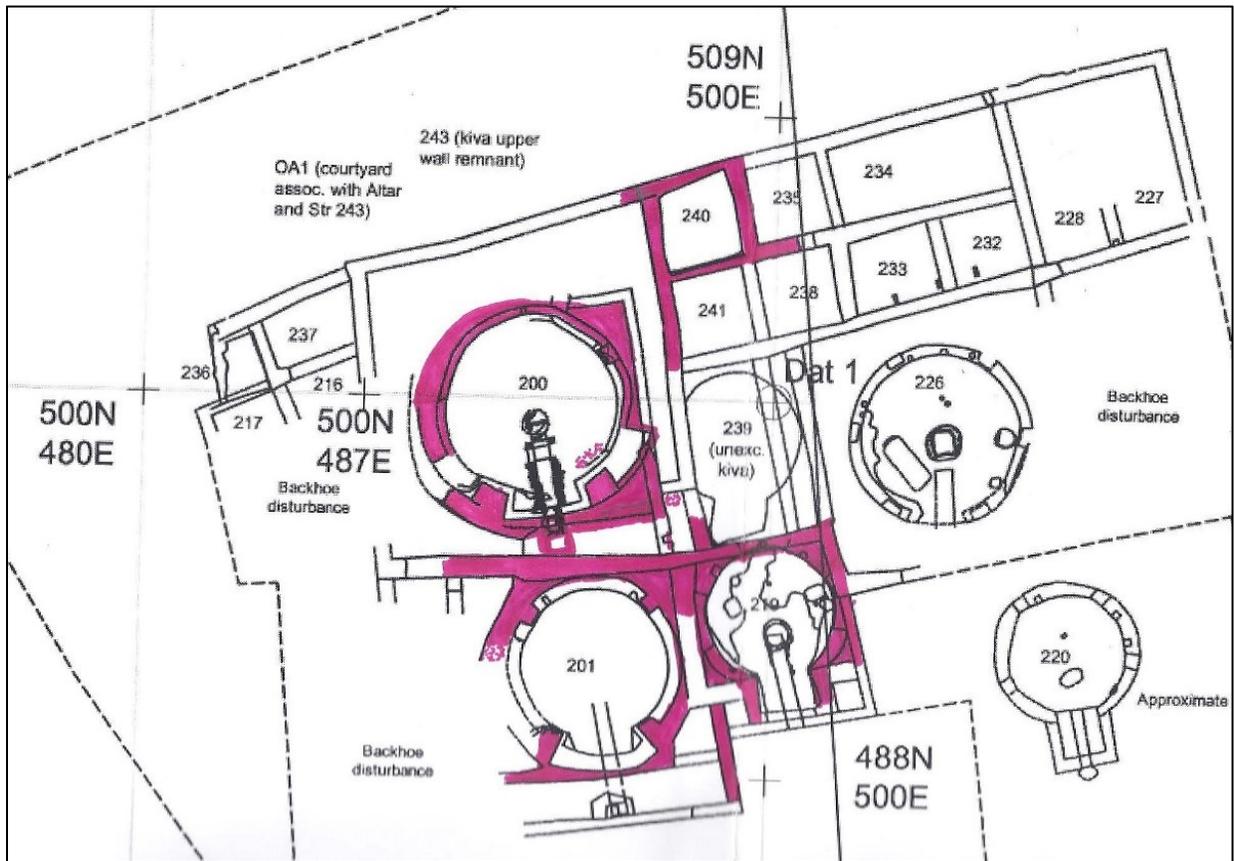
Figure 18. Detailed map of the exposed architecture within the east great house, the Haynie site. Walls stabilized by Crow Canyon are highlighted in pink.

In 2018, stabilization of walls in the east great house continued through the assessment and treatment of eight structures (Figure 18). Work focused on areas that posed a threat to visitor and staff safety and that would have minimal physical impact on the cultural and natural environments. Stabilization was undertaken on Kiva 200, the Kiva 200 courtyard, Kiva 201, the Kiva 201 courtyard, Kiva 219, the Kiva 219 courtyard, Room 240, and Room 241. Actions undertaken during this process include the following: (1) the addition or replacement of mortar to walls (pointing or repointing), (2) the securing of existing stones through the addition of mortar (relaying), (3) the addition of new stones to existing structures (new laying), (4) the placement of stones atop existing architecture (capping), (5) the removal of vegetation that poses a risk to the structural fabric of the site, and (6) the use of backfill and drainage contouring to support a structure and prevent further damage from natural elements (Diederichs 2018). Stabilization efforts utilized water, sediments from discrete backdirt piles, stones that had lost their original context, and mortar produced for stabilization. The mortar was created to match the original materials used in construction as closely as possible while providing durability to the structure. The stabilization mortar consists of 50 percent reconstituted mortar collected from “melted” mortar in the top of the extant wall, 45 percent light brown silt from alluvial deposits along the south boundary of the Haynie Ranch, LLC, property, and 5 percent Portland cement.

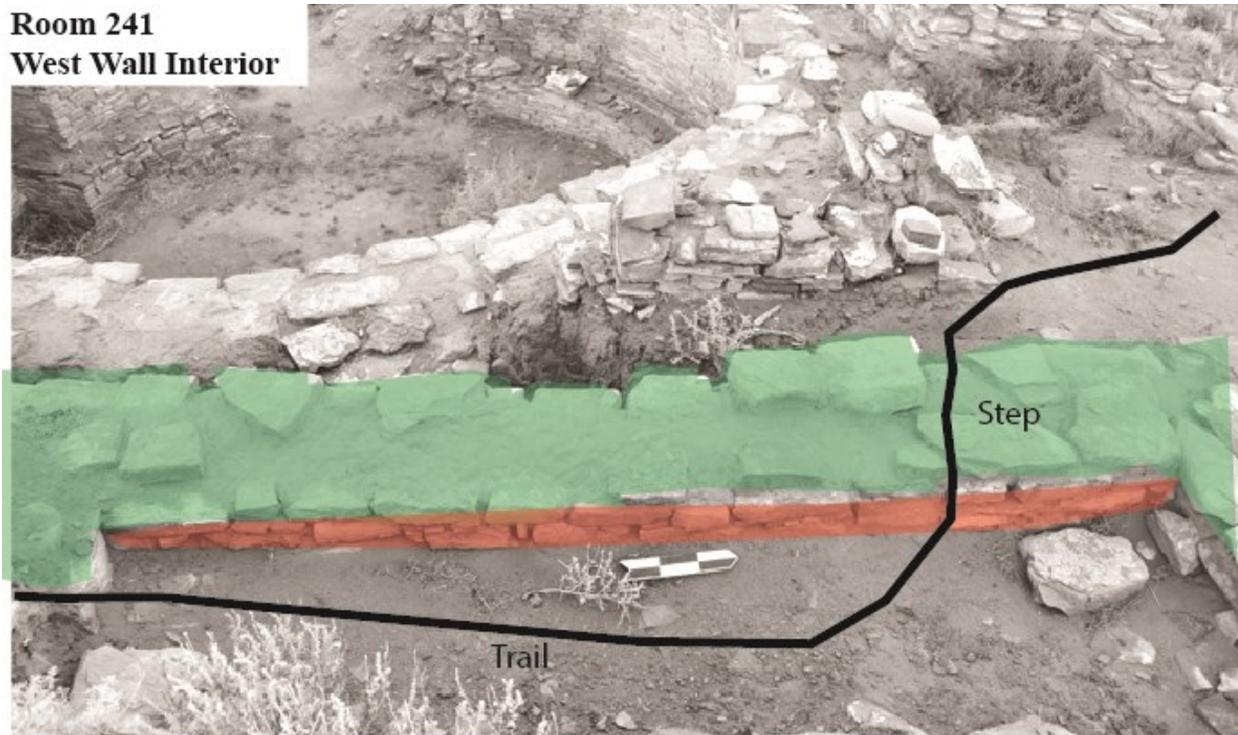
**Room 241
West Wall Interior**

Figure 19. Photograph of the interior of the west wall of Room 241 in the east great house showing stabilization work completed in 2018, the Haynie site.

great house mound (Figure 19). The primary stabilization treatment was the capping of wall tops, which occurred on all walls more than 5 ft tall. Additionally, any rodent holes were backfilled, exposed floor features were covered with plywood, and loose rock piles were removed from within structures. As noted, only issues that posed direct threats to the safety of Crow Canyon staff, participants, and visitors were addressed, and additional stabilization is recommended for seven of the structures (Diederichs 2018)

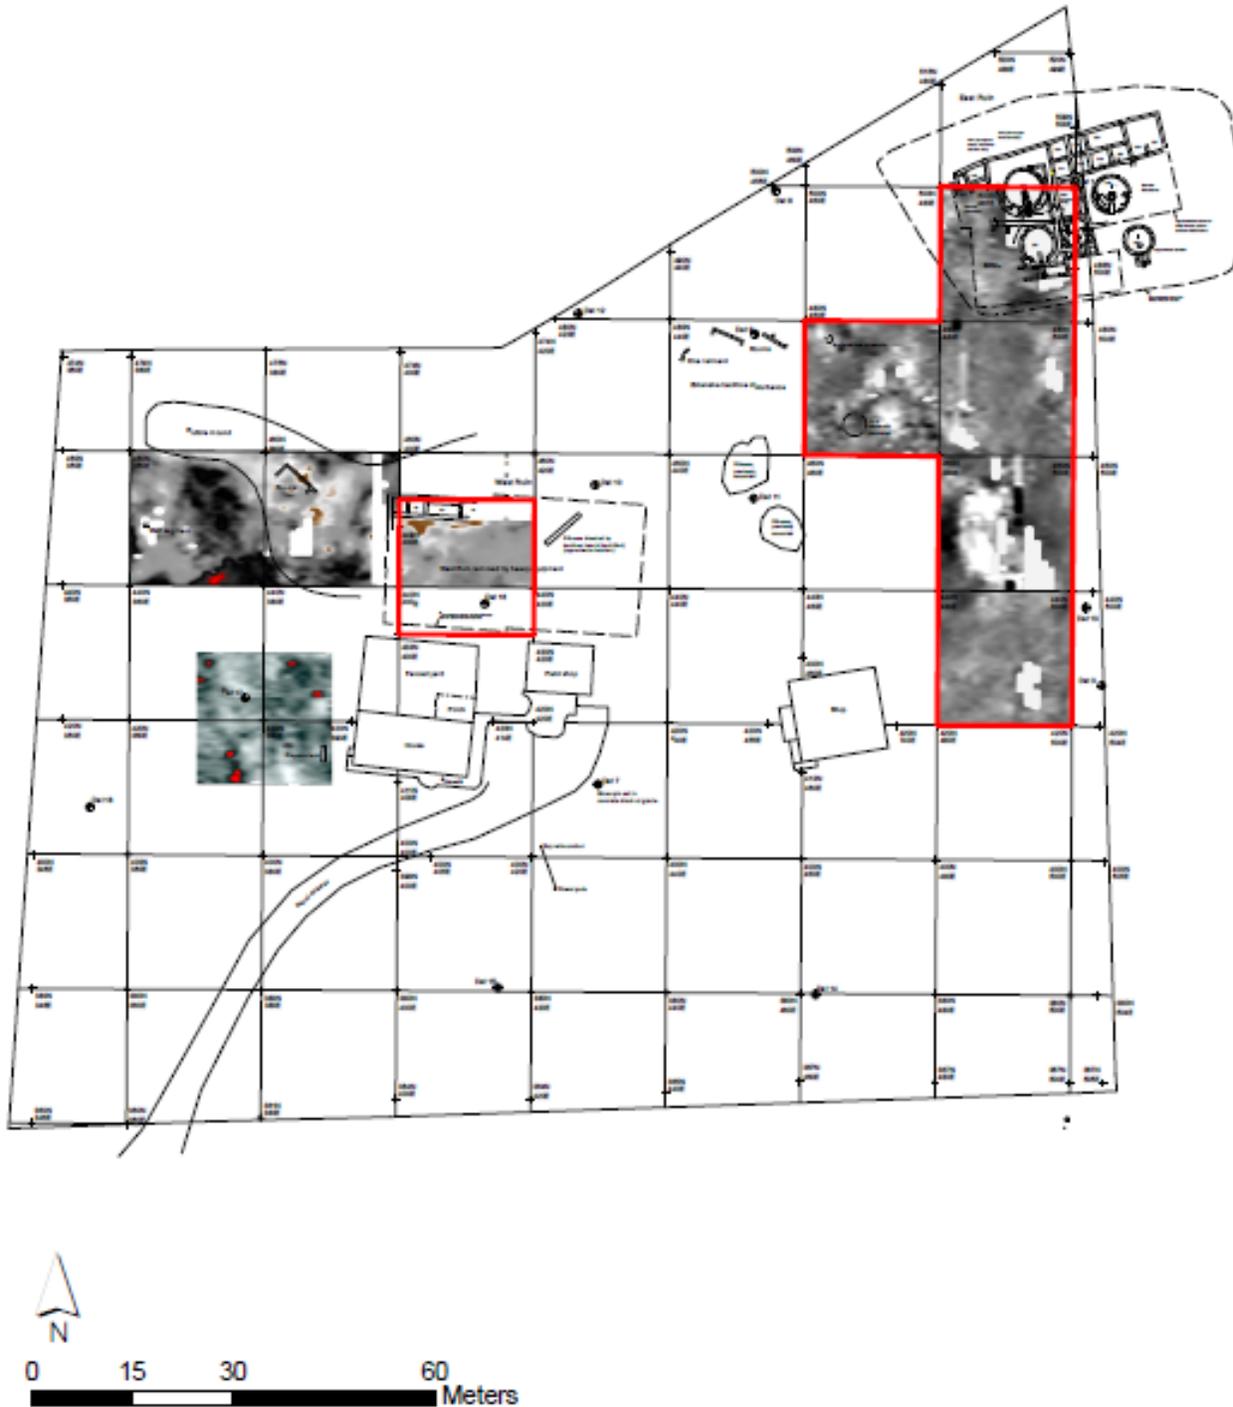
Figure 20. Areas outlined in red are locations of geophysical grids on the Haynie site (SMT1905). The five grids surveyed in 2018 are located along the east property line; the grid over the west great house was surveyed in 2017. Image created by Mona Charles, Powderhorn Research LLC, 2018.

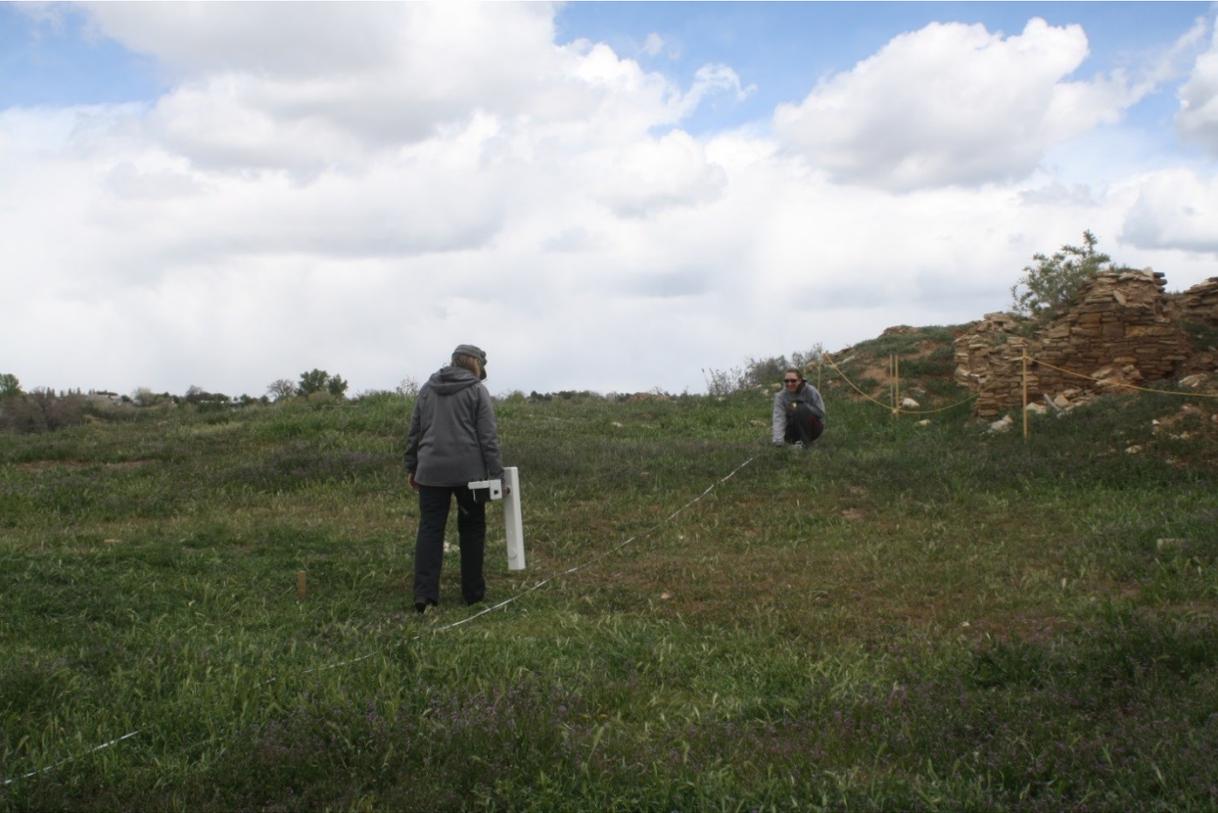
Figure 21. Mona Charles conducting gradiometer survey west of the east great house with Crow Canyon supervisory archaeologist Rebecca Simon assisting, the Haynie site.

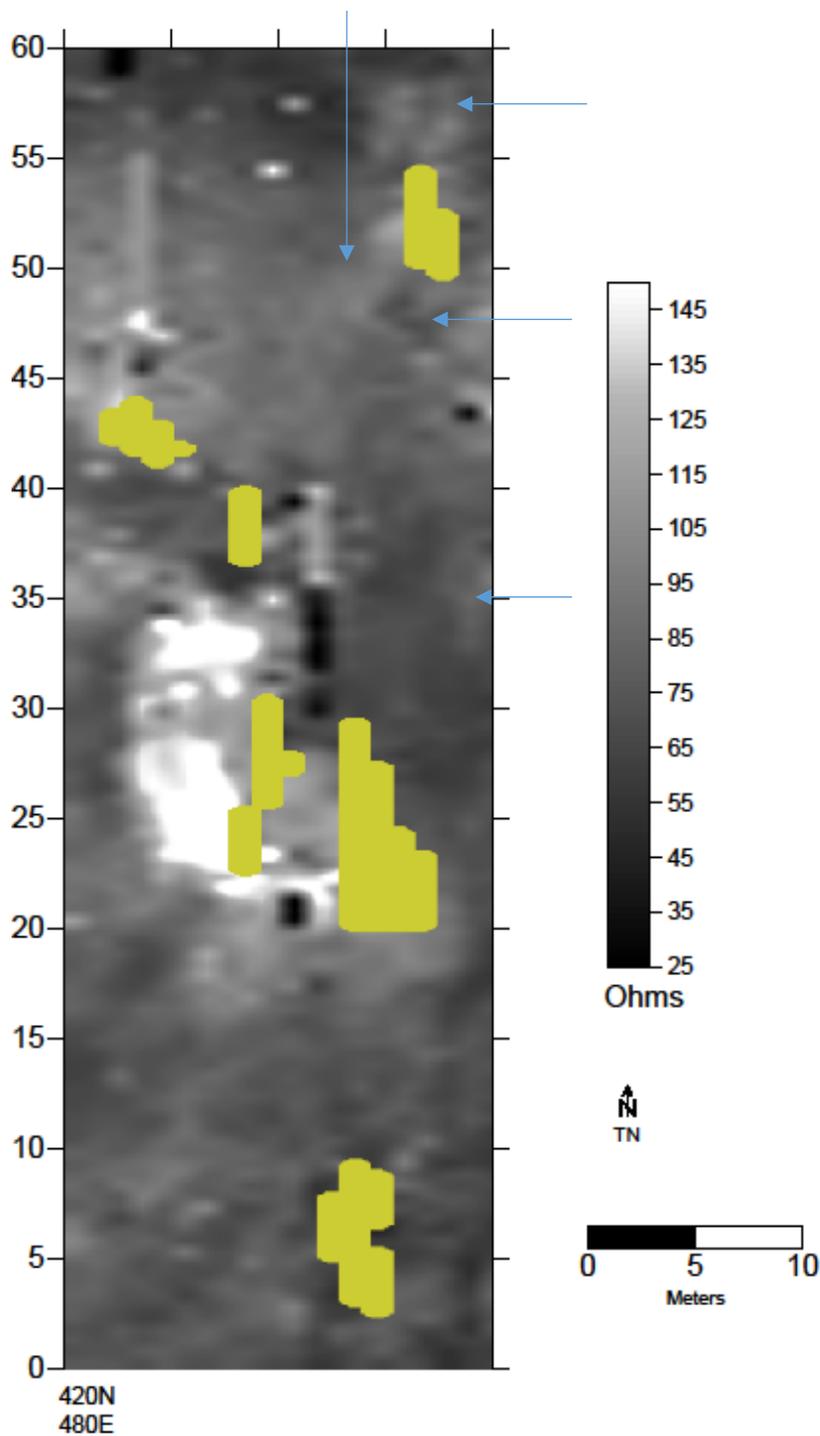
Figure 22. Electrical resistance survey conducted during 2018 of Grids 1, 2, and 3, the Haynie site. Yellow indicates dummy values, and blue arrows point to areas of interest for further investigation. Image created by Mona Charles, Powderhorn Research LLC, 2018.

Electrical resistance survey works on the principle that anomalies beneath the modern ground surface can be detected because their resistance to the flow of an electrical current deviates from the surrounding norm. The survey at the Haynie site (Figure 20) measured the distortion of an induced electrical field caused by subsurface phenomena such as archaeological structures or features. Grids 1, 2, and 3 (Figure 22) encompassed an area in the eastern portion of the site directly south of the east great house. The majority of this area had been previously disturbed by modern activities. Additionally, sandstone bedrock was exposed in portions of Grid 1. Despite this disturbance, several alignments were identified in the northeast quarter of these grids. The presence of straight lines and 90-degree corners suggest cultural remains.
