The Northern Chaco Outliers Project Annual Report, 2018 Field Season

*Samantha G. Fladd, Rebecca L. Simon, Susan C. Ryan, Shanna R. Diederichs,
Kari L. Schleher, Caitlin A. Sommer, Steven R. Copeland, and Grant D. Coffey*

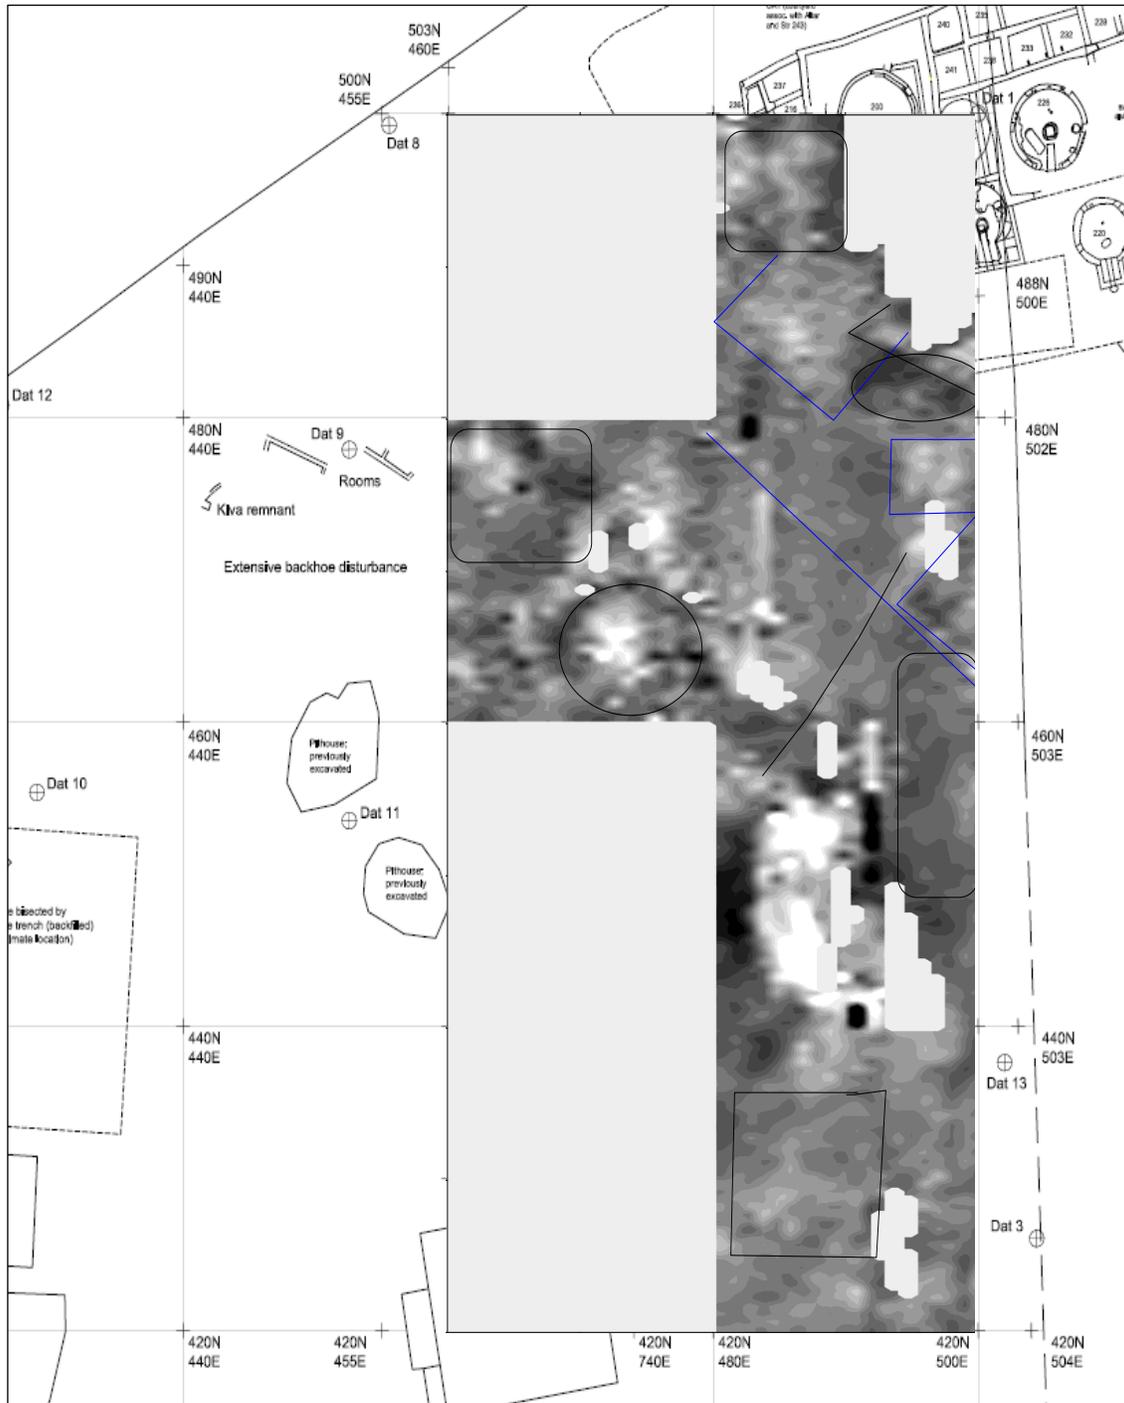
Figure 23. Electrical resistance survey conducted in 2018 of Grids 1, 2, 3, 4, and 5, the Haynie site. Areas of interest are highlighted in blue. Image created by Mona Charles, Powderhorn Research LLC, 2018.

Grid 4 was located west of Grid 3, southwest of the east great house (Figure 23). As with the first three grids, the area had been disturbed by various modern activities. However, a square in the northwest corner of Grid 4 was confidently identified as a prehistoric roomblock; walls visible at the modern ground surface confirm the existence and location of this structure. The final grid, Grid 5 (Figure 23), was placed immediately north of Grid 3. Portions of the extant east great house are included in the northeast corner of Grid 5. Although also disturbed by modern activities at the site, this grid included several alignments and anomalies that may indicate the presence of buried cultural features.
